NASA TM X-1266

EXPERIMENTAL EVALUATION
OF THROAT INSERTS IN
A STORABLE-PROPELLANT
ROCKET ENGINE

by Jerry M. Winter, Larry D. Plews, and James R. Johnston
Lewis Research Center
Cleveland, Ohio

NATIONAL AERONAUTICS AND SPACE ADMINISTRATION • WASHINGTON, D. C. • OCTOBER 1966

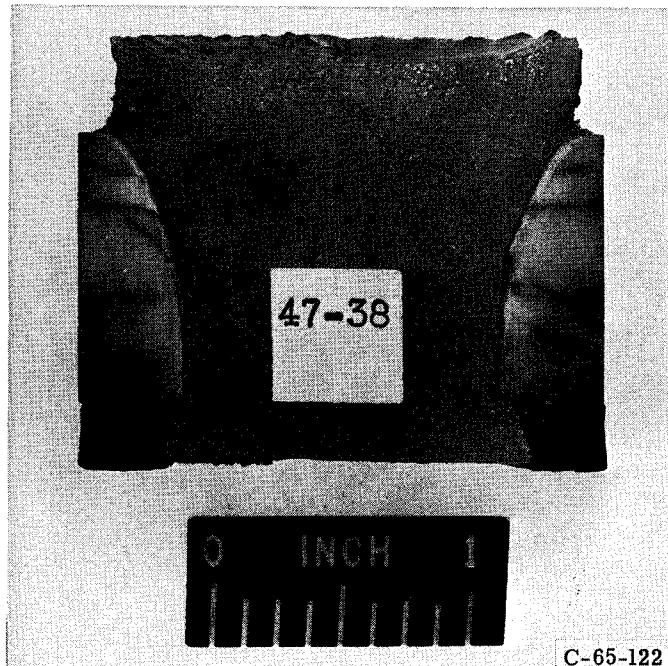
(21) Insert 21; configuration C; injector 11; characteristic length, 67; no coating

Material	Form	Manufacturer	Additional layer
Insert		High-density BeO	Hot pressed	Aerospace Corp	None
Envelope		Silica phenolic (MX 2641)	Cloth (90° to centerline)	Haveg	0.25-in.-thick stainless-steel shell
Run	Chamber pressure, P_c , psia	Oxidant-fuel ratio, O/F	Run time, sec	Total change in effective throat radius, ΔR , in.	Remarks
26	100.1 to 95.6	2.08	60.4	-0.006	Timer shutdown; insert cracked

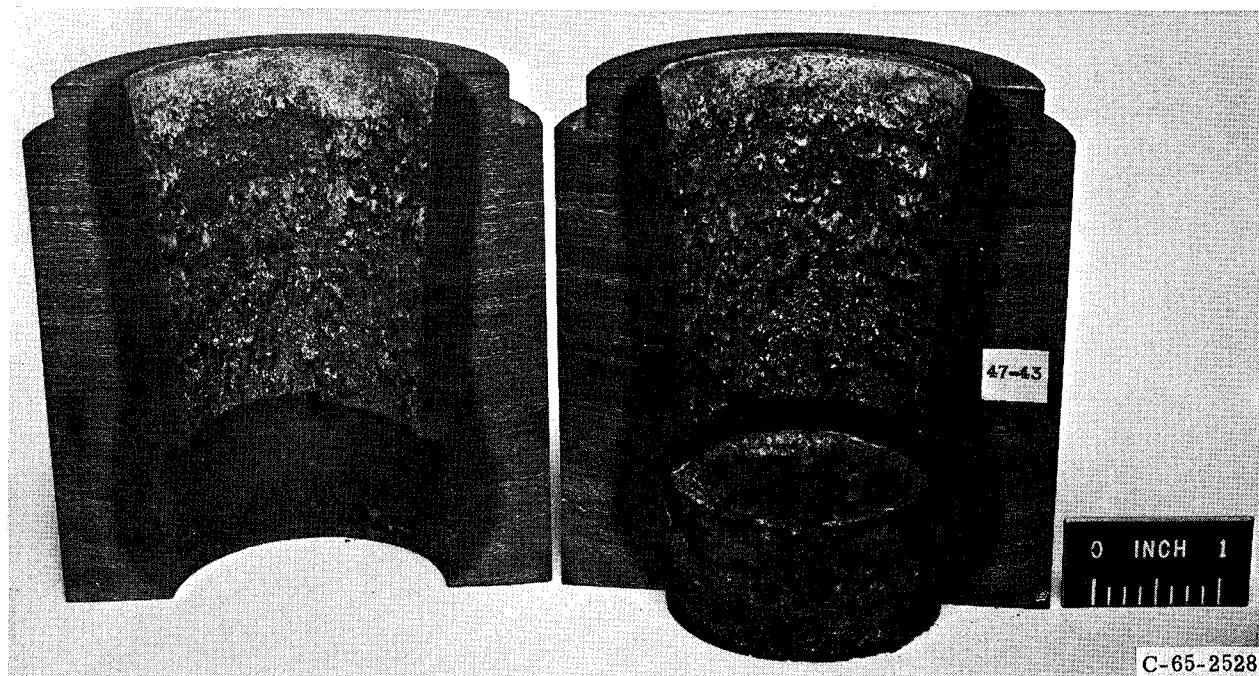
(22) Insert 22; configuration B; injector 11A; characteristic length, 67; no coating

Material		Form		Manufacturer	Additional layer
Insert		Pressed and sintered		Brush Beryllium	0.125-in.-thick stainless-steel sleeve with 0.005 interference fit
Envelope		Silica phenolic (MX 2641)		Haveg	0.25-in.-thick stainless-steel shell
Run	Chamber pressure, P_c , psia	Oxidant-fuel ratio, O/F	Run time, sec	Total change in effective throat radius, ΔR , in.	Remarks
113	101 to 100.5	2.10	58.8	0.003	Timer shutdown; no cracks visible
147	95.9 to 93.7	2.10	54.1	.049	Low chamber pressure shutdown; circumferential cracks
			<u>112.9</u>

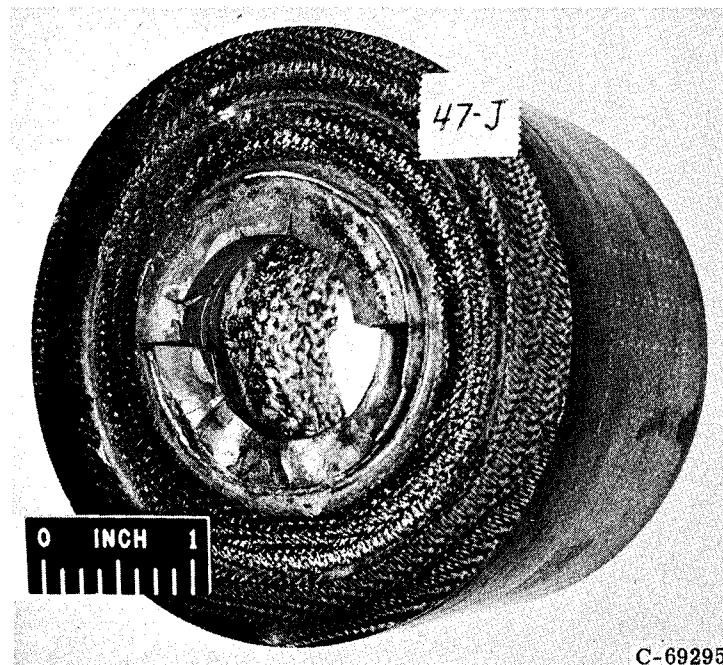
(23) Insert 23; configuration B; injector 12; characteristic length, 50; no coating

Material	Form	Manufacturer	Additional layer
Insert		NbC		Kennametal	0.040-in.-thick Rokide Z on insert outside diameter
Envelope		Silica phenolic (MX 2641)	Tape (90° to centerline)	Haveg	0.25-in.-thick stainless-steel shell
Run	Chamber pressure, P_c , psia	Oxidant-fuel ratio, O/F	Run time, sec	Total change in effective throat radius, ΔR , in.	Remarks
215	97 to 93	1.75	56.0	---	Low chamber pressure; shutdown; severe cracking

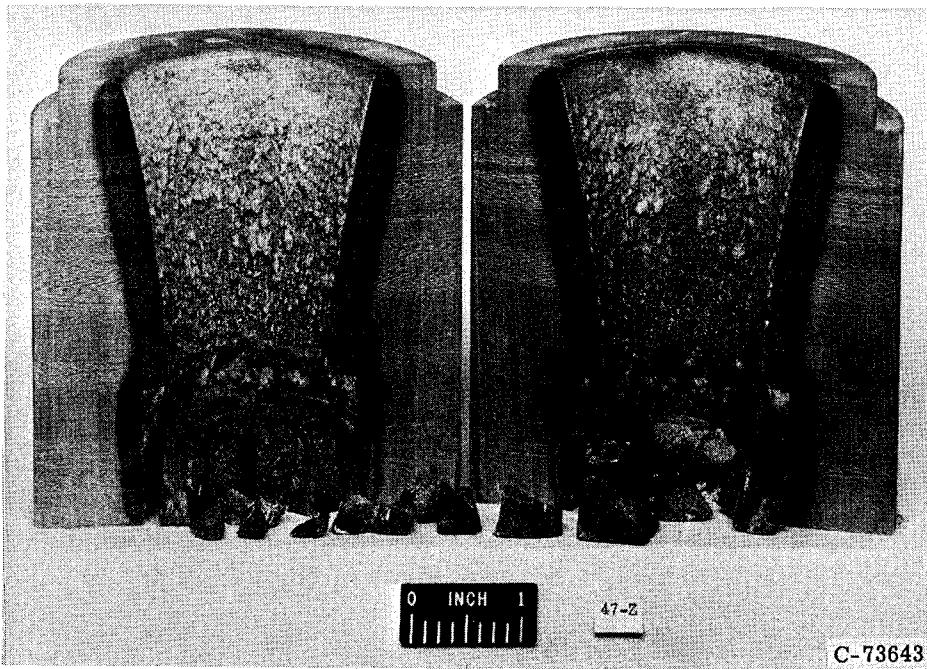
(24) Insert 24; injector 11; characteristic length, 67; no coating

Material		Form		Manufacturer	Config- uration	Additional layer
Insert		Segmented SiC		Carborundum	B ^a	None
Envelope		Silica phenolic (MX 2641)		Cloth (90° to centerline)	Haveg	B 0.25-in.-thick stainless-steel shell
Run	Chamber pressure, P_c , psia	Oxidant-fuel ratio, O/F	Run time, sec	Total change in effective throat radius, ΔR , in.	Remarks	
426	110.0 to 104.0	1.98	52.2	0.0245 (calc)	Insert lost because of ablative failure

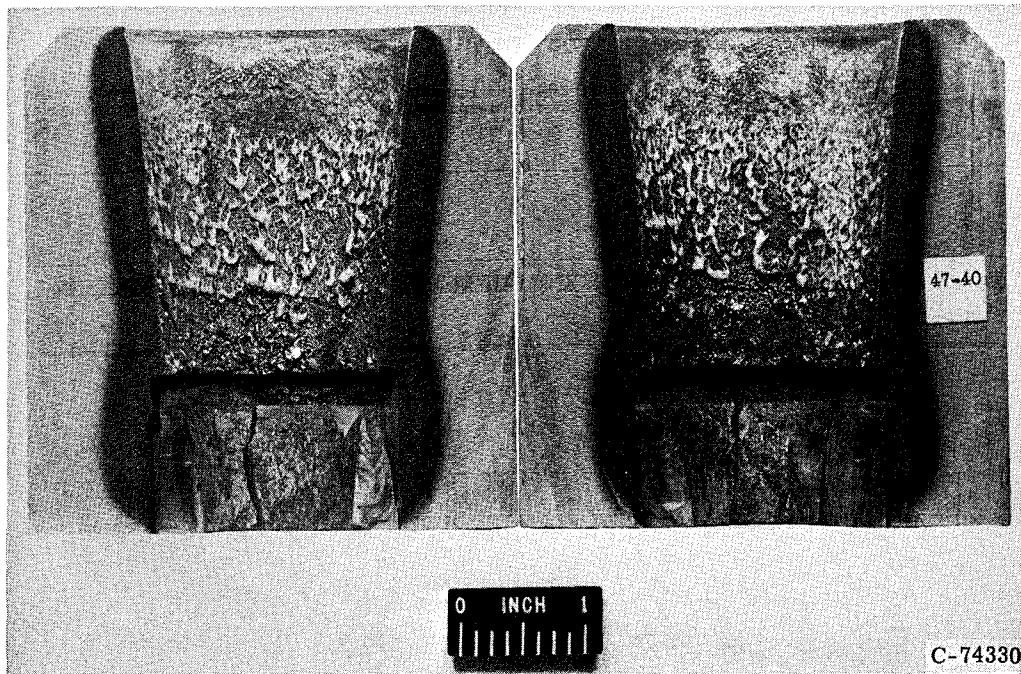
(26) Insert 26; configuration C; injector 11; characteristic length, 67; no coating

Material	Form	Manufacturer	Additional layer
Insert		SiC	Hot pressed	Aerospace Corp	None
Envelope		Silica phenolic (MX 2641)	Cloth (90° to centerline)	Haveg	0.25-in. -thick stainless-steel shell
Run	Chamber pressure, P_c , psia	Oxidant-fuel ratio, O/F	Run time, sec	Total change in effective throat radius, ΔR , in.	Remarks
35	101.1 to 96.4	2.09	65.3	0.010	Timer shutdown; axial cracks

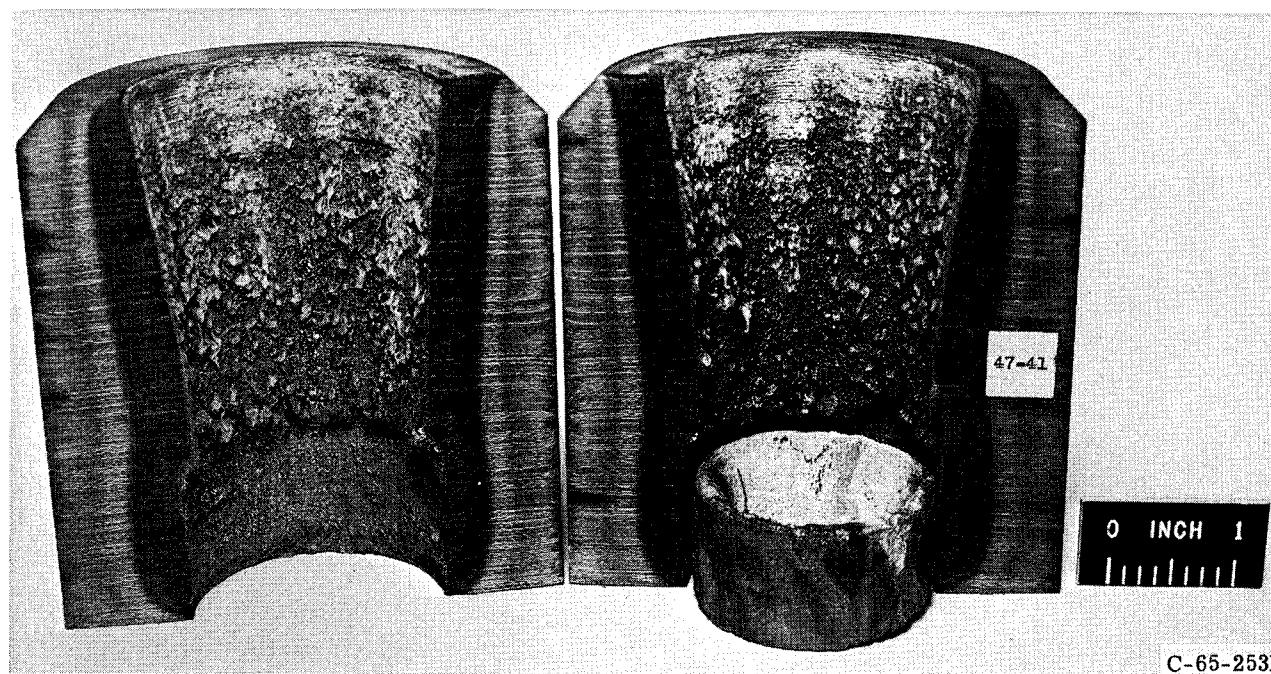
(28) Insert 28; configuration C; characteristic length, 62; no coating

Material		Form		Manufacturer	Additional layer
Insert		Hypereutectic ZrC (78 Zr - 22 C (2 percent free C))		Cast		Aerospace Corp	None
Envelope		Silica phenolic (MX 2641)		Cloth (90° to centerline)		Haveg	0.25-in.-thick stainless-steel shell
Run	Injector	Chamber pressure, P_c , psia	Oxidant-fuel ratio, O/F	Run time, sec	Total change in effective throat radius, ΔR , in.	Remarks	
45	11	104.5 to 90.0	1.95	60.5	0	Timer shutdown; thin ZrO_2 coating	
196	11A	99.1 to 99.1	1.93	66.4	0	Timer shutdown; thin ZrO_2 coating	
				126.9

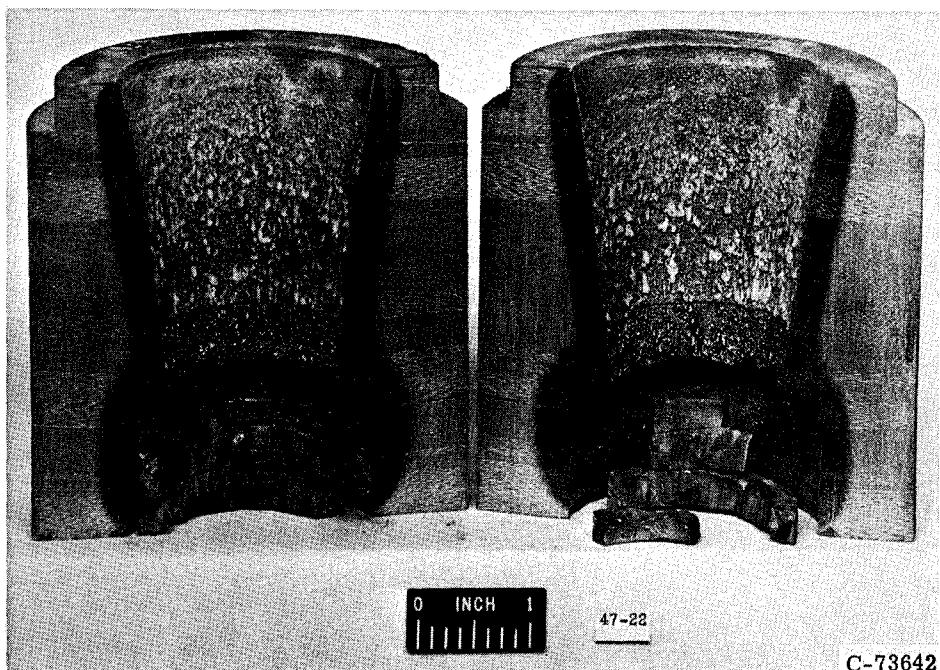
(29) Insert 29; configuration B; injector 11; characteristic length, 67; no coating

Material		Form		Manufacturer	Additional layer
Insert		TiB ₂		Norton	0.125-in.-thick stainless-steel sleeve with 0.005 interference fit
Envelope		Silica phenolic (MX 2641)		Cloth (90° to centerline)	Haveg
Run	Chamber pressure, P _c , psia	Oxidant-fuel ratio, O/F	Run time, sec	Total change in effective throat radius, ΔR, in.	Remarks
411	110.0 to 91.5	2.05	33.7	---	Low chamber pressure shutdown; severe cracking

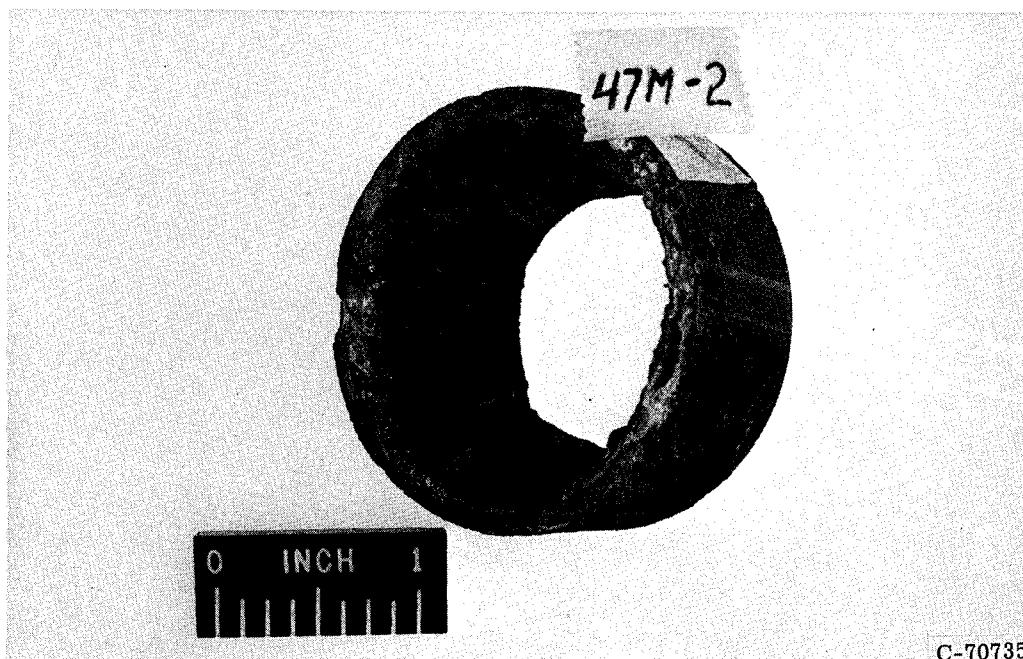
(32) Insert 32; injector 11; characteristic length, 67; no coating

Material	Form	Manufacturer	Configura-tion	Additional layer
Insert	Mo	Sintered		C ^a	0.04-in.-thick Rokide Z on outside diameter of insert
Envelope	Silica phenolic (MX 2641)	Cloth (90° to centerline)	Fiberite	C	0.25-in.-thick stainless-steel shell
Run	Chamber pressure, P_c , psia	Oxidant-fuel ratio, O/F	Run time, sec	Total change in effective throat radius, ΔR , in.	Remarks
316	106 to 101	1.86	42.7	0.0075	Failure of insert ablative leading edge

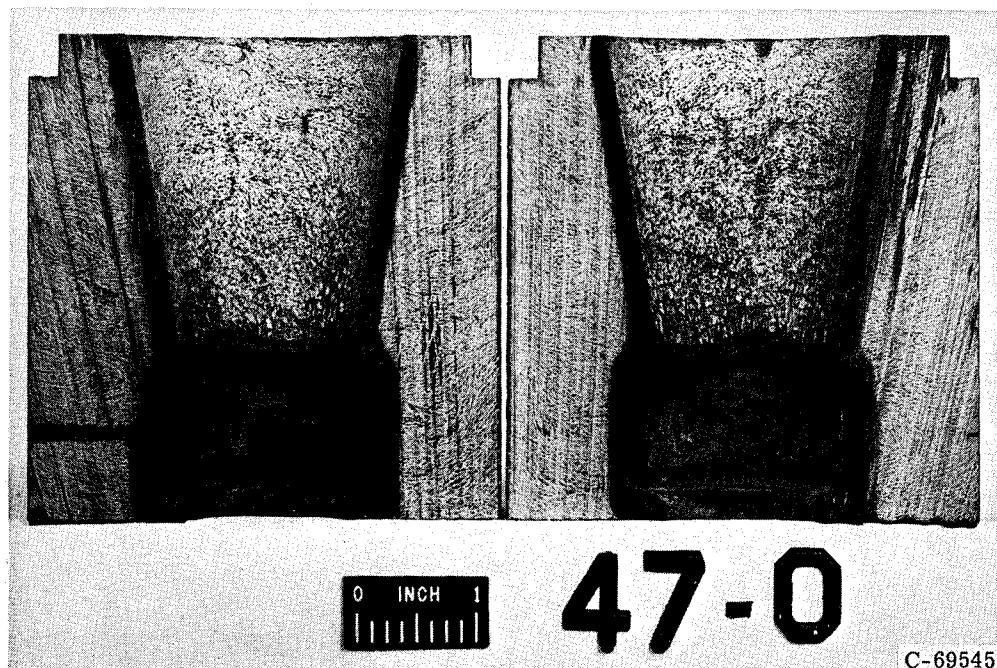
(33) Insert 33; configuration B; injector 11; characteristic length, 67; no coating

Material	Form	Manufacturer	Additional layer
Insert		Nb		Wah Chang	0.040-in.-thick Rokide Z on insert outside diameter
Envelope		Silica phenolic (MX 2641)	Chopped squares	Haveg	0.25-in.-thick stainless-steel shell
Run	Chamber pressure, P_c , psia	Oxidant-fuel ratio, O/F	Run time, sec	Total change in effective throat radius, ΔR , in.	Remarks
232	96.5 to 89.5	1.67	17.4	---	Low chamber pressure shutdown; insert completely consumed

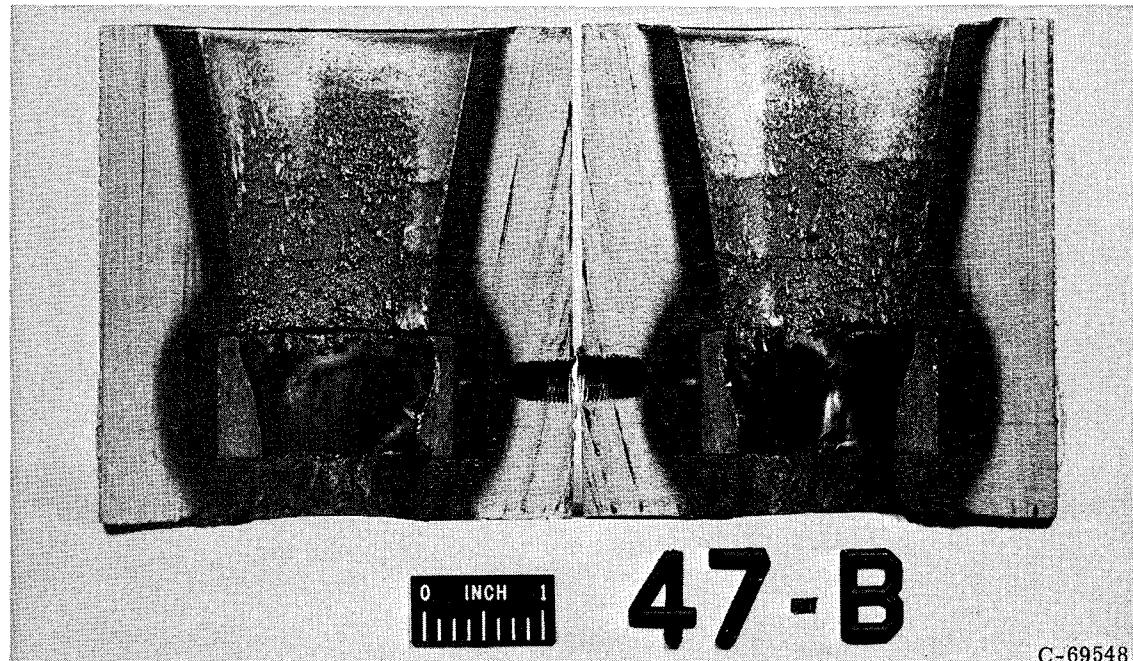
(34) Insert 34; configuration B; no coating

Material		Form		Manufacturer		Additional layer		
Insert		Mo		Arc cast		NASA		1/4-in.-thick graphite cloth sleeve on insert outside diameter		
Envelope		Silica phenolic (MX 2641)		Cloth (90° to centerline)		Fiberite		None		
Run	Injector	Character- istic length, L^* , in.	Chamber pressure, P_c , psia	Oxidant-fuel ratio, O/F	Run time, sec	Total change in effective throat radius, ΔR , in.	Remarks			
223	12	50	100.5	1.68	20.2	-----	Manual abort; lost TC seal			
229	11	67	99.5 to 89.5	1.88	39.7	0.045 (calc)	Low chamber pres- sure shutdown			
					59.9

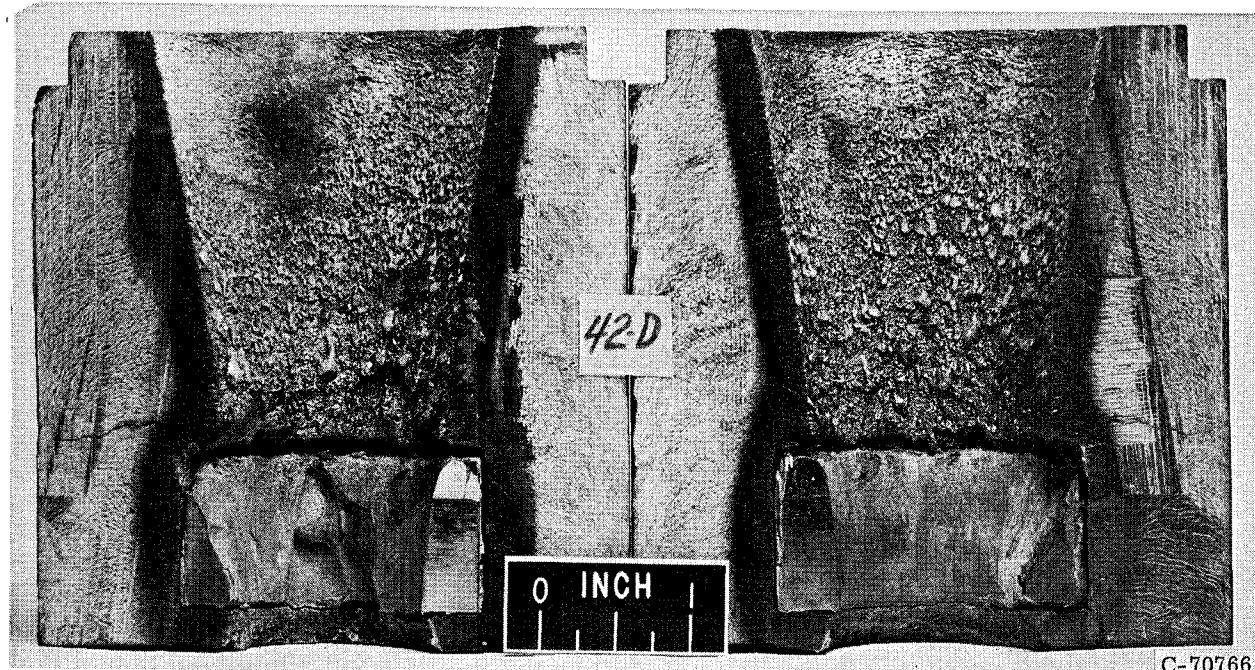
(35) Insert 35; configuration B; no coating

Material		Form		Manufacturer		Additional layer	
Insert		90 Ta - 10 W		Arc cast		NASA		0.030-in. -thick Rokide Z on insert outside diameter	
Envelope		Silica phenolic (MX 2641)		Chopped squares		Fiberite		0.25-in. -thick stainless-steel shell	
Run	Injector	Characteristic length, L*, in.	Chamber pressure, P _c , psia	Oxidant-fuel ratio, O/F	Run time, sec	Total change in effective throat radius, ΔR, in.	Remarks		
206	12	50	106	1.87	11.3	0	Ablative cracked but was replaced		
241	11	67	100.7 to 91.2	1.96	31.4	.042	Low chamber pressure shutdown; insert cracked		
					42.7

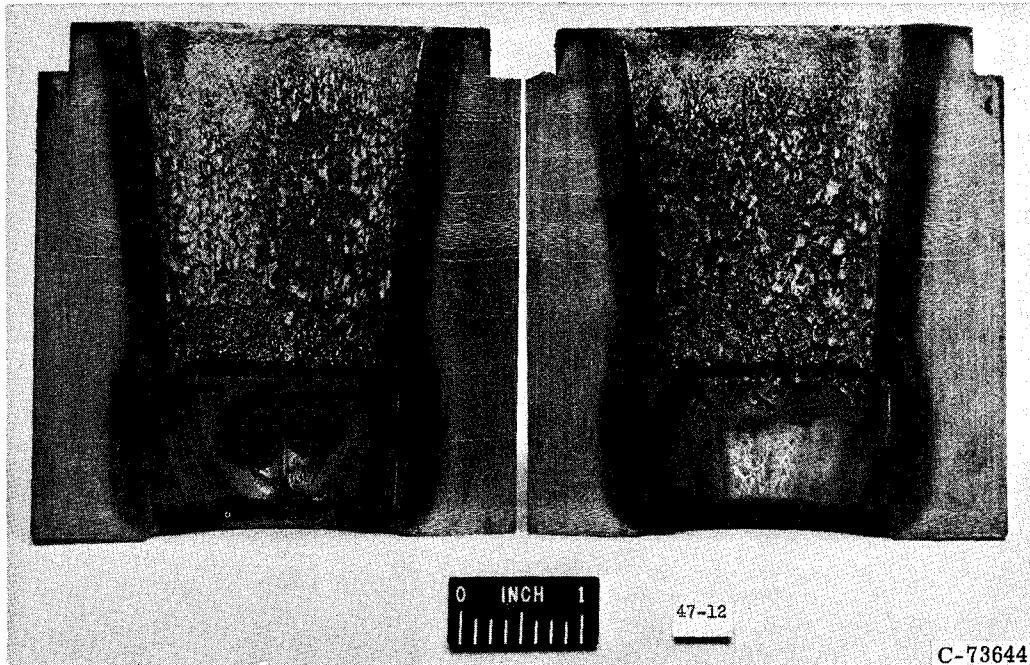
(36) Insert 36; configuration C; injector 11; characteristic length, 67; no coating

Material		Form		Manufacturer	Additional layer
Insert		TZM alloy (99 Mo - 0.5 Ti - 0.5 Zr)		Cleveland Tungsten	0.045-in.-thick Rokide Z on in- sert outside diameter
Envelope		Silica phenolic (MX 2641)		Haveg	0.25-in.-thick stainless-steel shell
Run	Chamber pressure, P_c , psia	Oxidant-fuel ratio, O/F	Run time, sec	Total change in effective throat radius,	Remarks
413	108.5 to 90.5	2.14	42.6	0.1055	Low chamber pres- sure shutdown

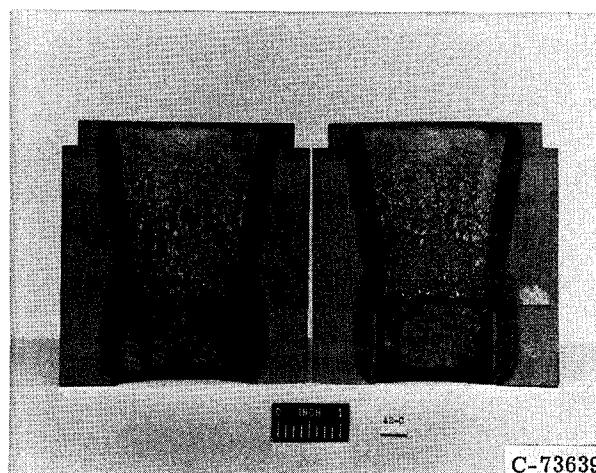
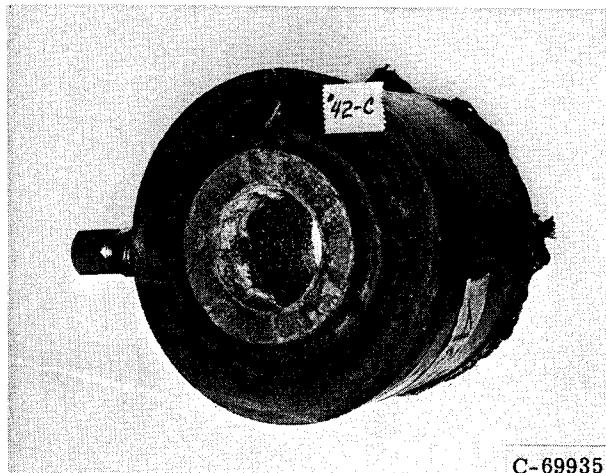
(37) Insert 37; configuration B; characteristic length, 67; no coating

Material		Form		Manufacturer		Additional layer
Insert		80 W - 20 Ag		Sintered and infiltrated		Firth-Sterling		0.030-in.-thick Rokide Z on insert outside diameter
Envelope		Silica phenolic (MX 2641)		Cloth (90° to centerline)		Fiberite		None
Run	Injector	Chamber pressure, P_c , psia	Oxidant-fuel ratio, O/F	Run time, sec	Total change in effective throat radius, ΔR , in.	Remarks		
255	10	99.7 to 95.9	2.08	59.8	0.020	Leading edge eroded and ablative cracked Low chamber pressure shutdown		
409	11	107.5 to 90.5	2.20	47.8 107.6	.0955

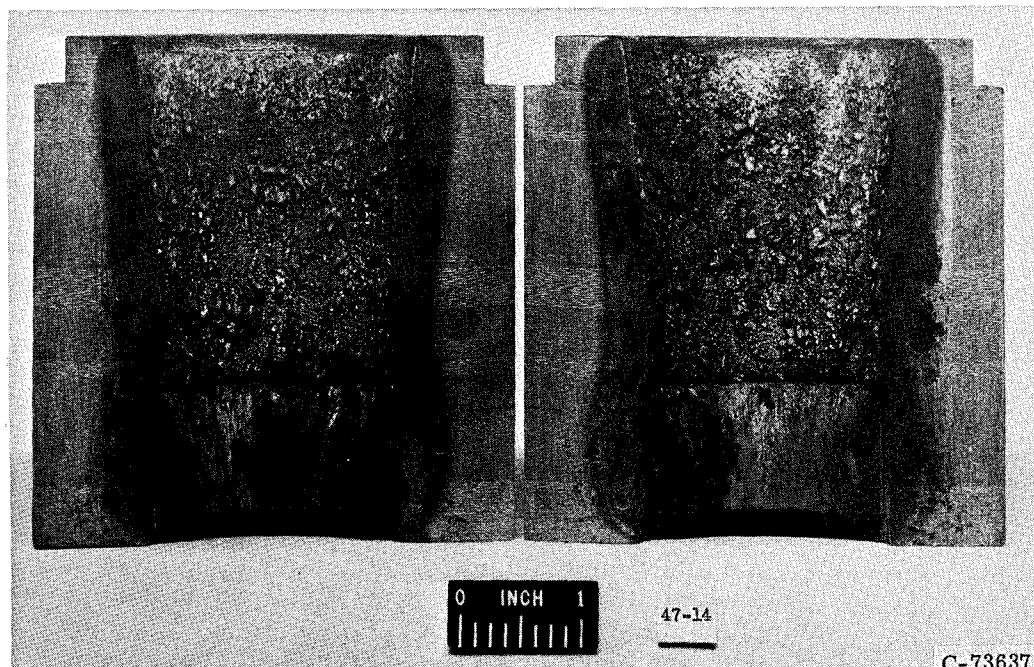
(39) Insert 39; configuration C; injector 11; characteristic length, 67; no coating

Material	Form	Manufacturer	Additional layer
Insert		80 W - 20 Cu	Sintered Cu infiltrated	Mallory	0.042-in. -thick Rokide Z on insert outside diameter
Envelope		Silica phenolic (MX 2641)	Cloth (90° to centerline)	Haveg	0.25-in. -thick stainless-steel shell
Run	Chamber pressure, P_c , psia	Oxidant-fuel ratio, O/F	Run time, sec	Total change in effective throat radius, ΔR , in.	Remarks
6	102.0 to 93.1	2.00	59.4	0.0475	Timed shutdown

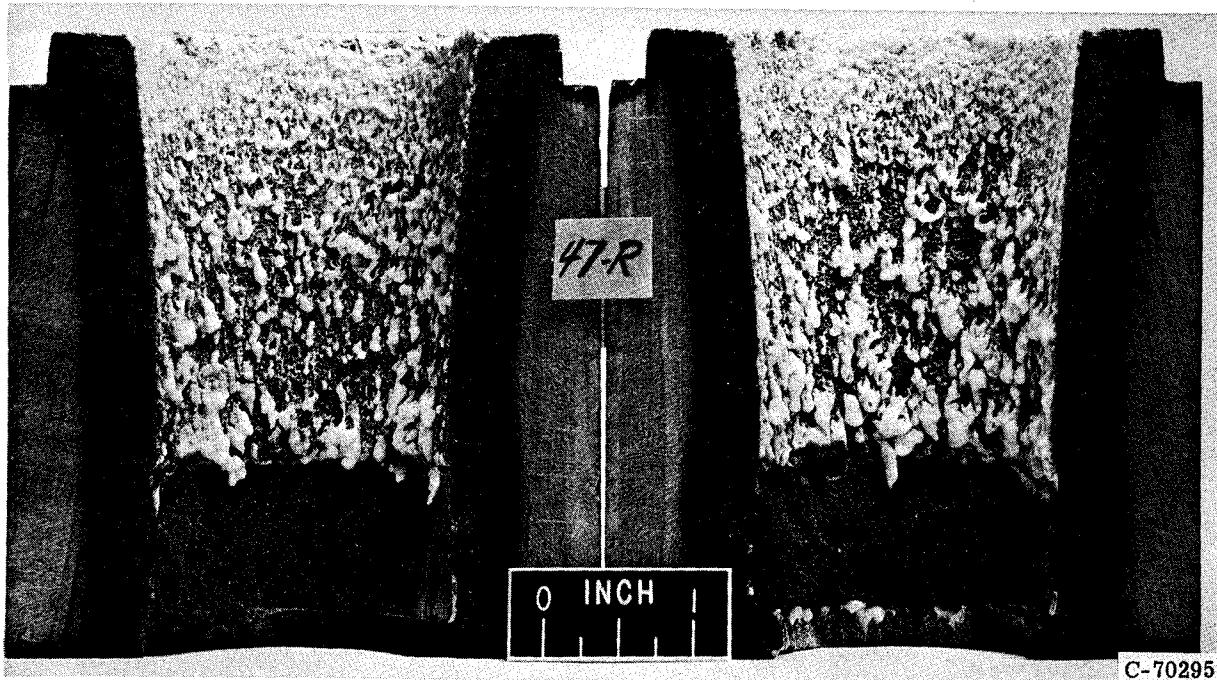
(40) Insert 40; configuration C; characteristic length, 67; no coating

Material	Form		Manufacturer	Additional layer
Insert		Heat-treated high-density graphite	Molded		American Metal Products	0.04-in.-thick Rokide Z on insert outside diameter
Envelope		Silica phenolic (MX 2641)	Molded squares		Haveg	0.25-in.-thick stainless-steel shell
Run	Injector	Chamber pressure, P_c , psia	Oxidant-fuel ratio, O/F	Run time, sec	Total change in effective throat radius, ΔR , in.	Remarks
266	10	104 to 98	2.10	65.3	0.015	Timed shutdown
271	10	94.5 to 91	2.03	46.1	.040	Low chamber pressure shutdown
277	11	112 to 90.5	2.01	33.4	.1555	Low chamber pressure shutdown
				144.8

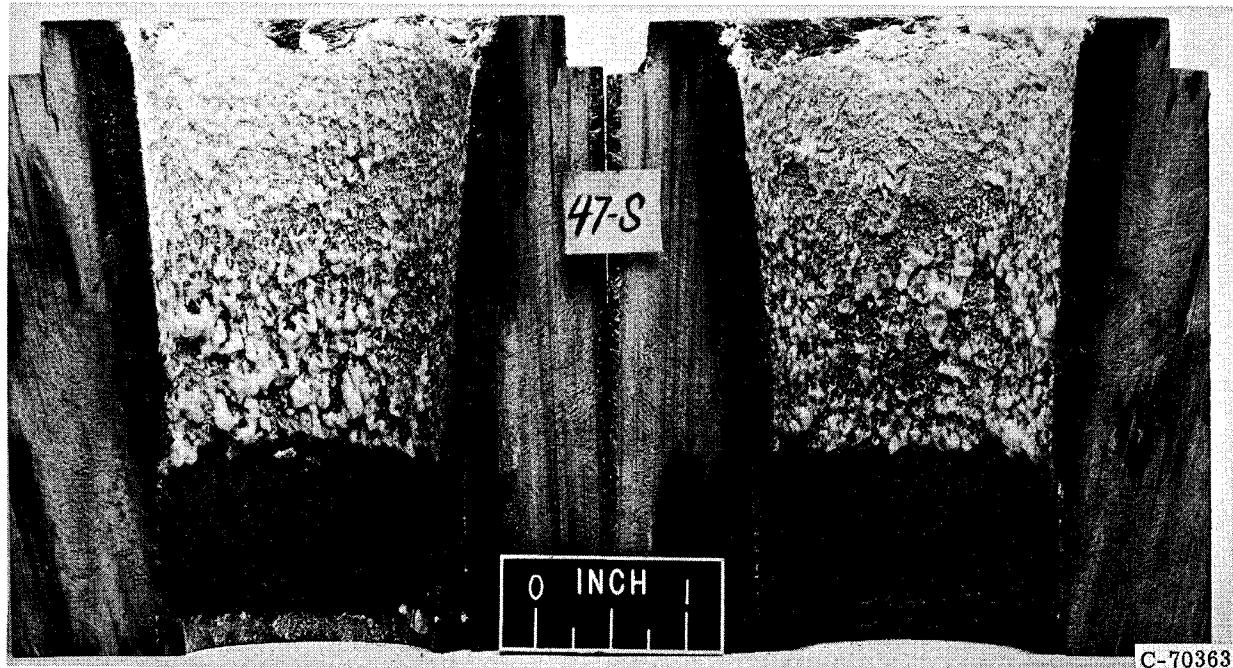
(41) Insert 41; configuration C; characteristic length, 67; no coating

Material	Form		Manufacturer	Additional layer
Insert		High-density graphite	Molded		American Metal Products	0.040-in.-thick Rokide Z on insert outside diameter
Envelope		Silica phenolic (MX 2641)	Molded squares		Haveg	0.25-in.-thick stainless-steel shell
Run	Injector	Chamber pressure, P_c , psia	Oxidant-fuel ratio, O/F	Run time, sec	Total change in effective throat radius, ΔR , in.	Remarks
267	10	101 to 91.5	2.13	53.7	0.0415	Low chamber pressure shutdown
278	11	103.5 to 90	1.92	26.0	.111	Low chamber pressure shutdown
281	11	96 to 90	2.07	16.1	.150	Low chamber pressure shutdown
				95.8

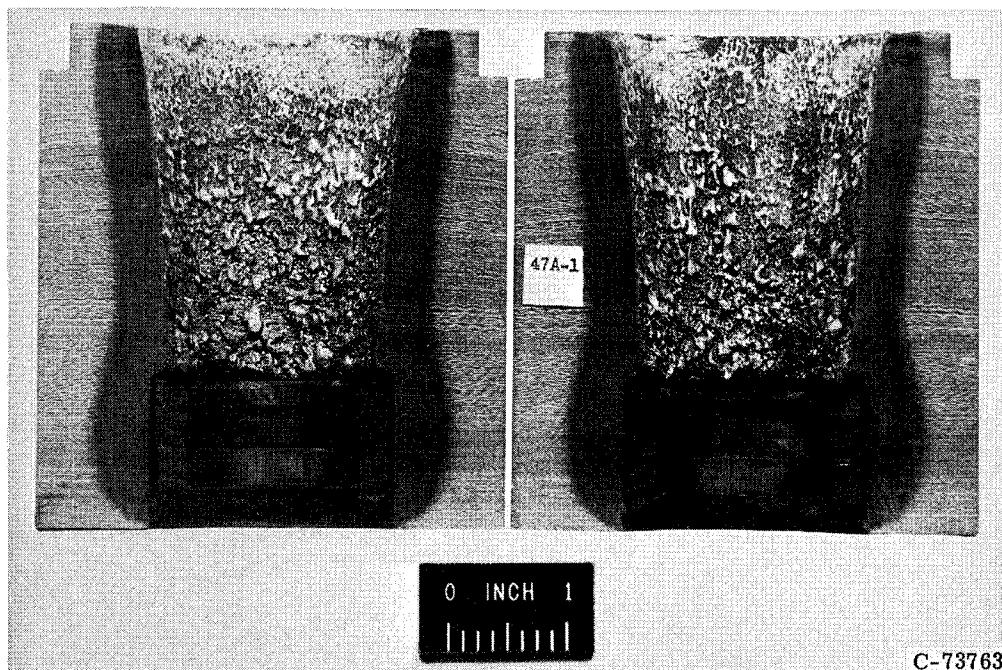
(42) Insert 42; configuration A; injector 11; characteristic length, 65; no coating

Material	Form	Manufacturer	Additional layers
Insert		Pyrolytic graphite	Washers with ab radial plane	General Electric	0.040-in.-thick Rokide Z on insert outside diameter
Envelope		Silica phenolic (MX 2641)	Cloth (90° to centerline)	Haveg	0.25-in.-thick stainless-steel shell
Run	Chamber pressure, P_c , psia	Oxidant-fuel ratio, O/F	Run time, sec	Total change in effective throat radius, ΔR , in.	Remarks
15 19	101.8 to 94.6 94.9 to 88.4	2.24 2.16	60.0 39.0 99.0	0.0475 .092	Timed shutdown Low chamber pressure shutdown

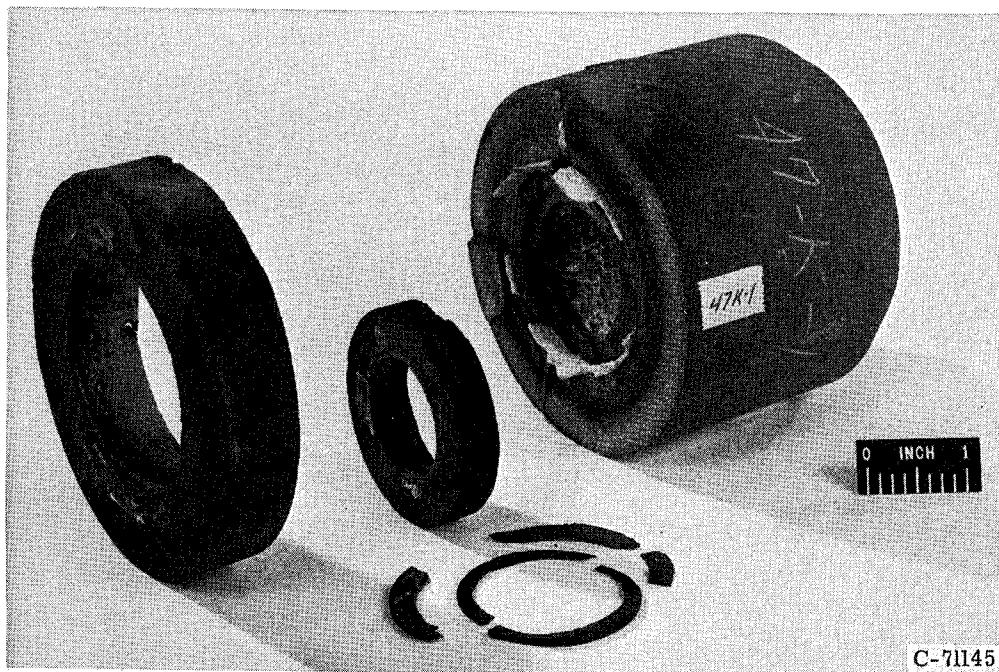
(43) Insert 43; configuration B; injector 11; characteristic length, 65; no coating

Material		Form		Manufacturer	Additional layer
Insert		Pyrolytic graphite		Washers with ab radial plane	Space Age Materials
Envelope		Silica phenolic (MX 2641)		Cloth (90° to centerline)	Fiberite
Run	Chamber pressure, P_c , psia	Oxidant-fuel ratio, O/F	Run time, sec	Total change in effective throat radius, ΔR , in.	Remarks
321	105 to 103	1.96	75.3	0.0135	Timed shutdown
340	100 to 99	1.86	95.7	-----	Manual shutdown; delamination failure
			171.0

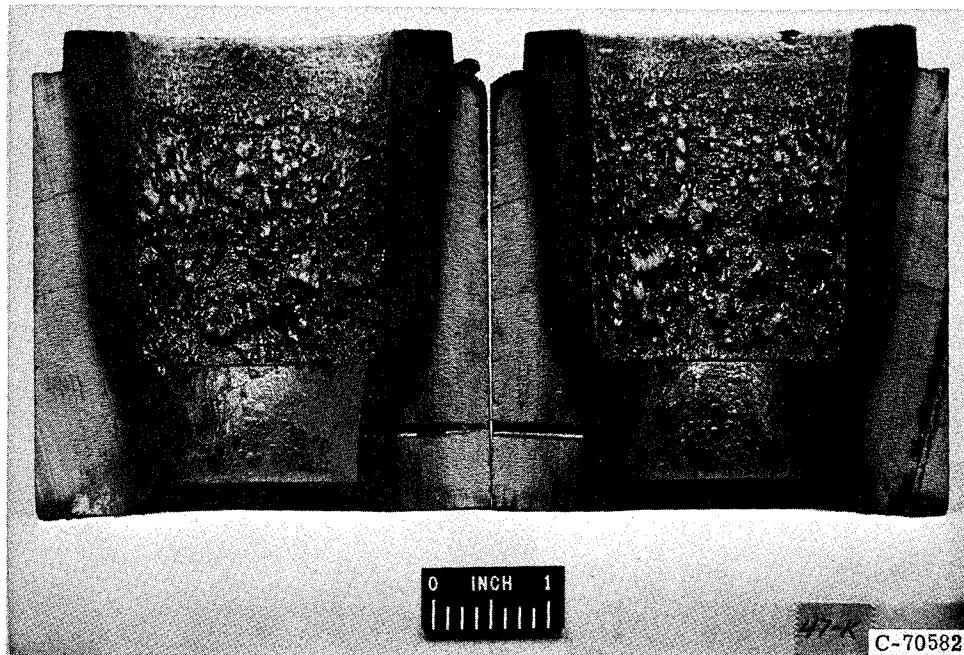
(44) Insert 44; configuration B; injector 11; characteristic length, 65; no coating

Material	Form	Manufacturer	Additional layer
Insert		Pyrolytic graphite	Concentric cylinders with ab axial plane	Space Age Materials	0.100-in.-thick asbestos sleeve on insert outside diameter
Envelope		Silica phenolic (MX 2641)	Cloth (90° to centerline)	Haveg	0.25-in.-thick stainless-steel shell
Run	Chamber pressure, P_c , psia	Oxidant-fuel ratio, O/F	Run time, sec	Total change in effective throat radius, ΔR , in.	Remarks
280	103 to 91	1.84	57.6	0.0565	Low chamber pressure shutdown; delamination
296	104 to 96	1.78	53.8	.0945	Low chamber pressure shutdown; delamination
299	102.5 to 94.5	1.73	68.7 180.1	.2195	Low chamber pressure shutdown; delamination

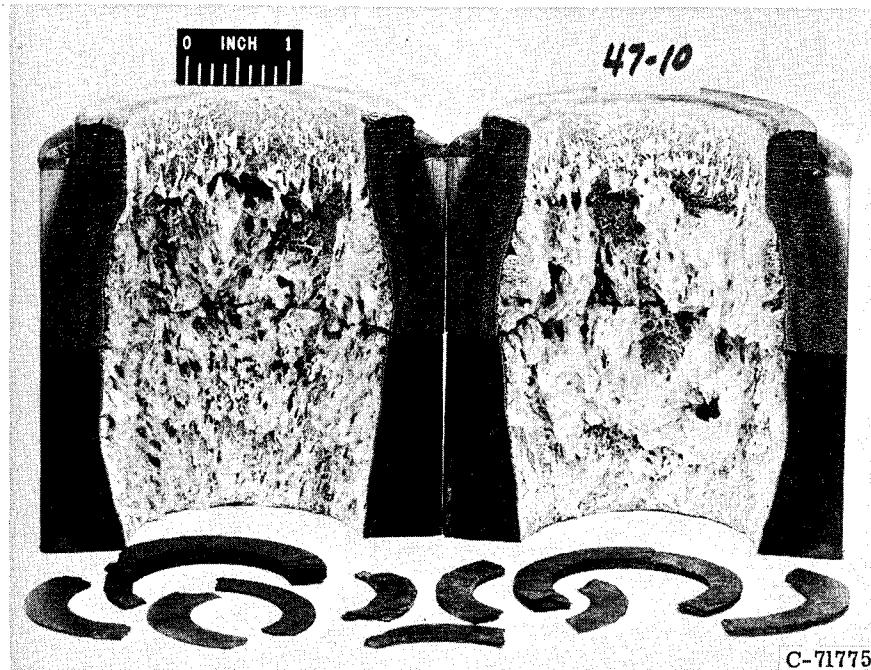
(45) Insert 45; configuration E; injector 11; characteristic length, 66; no coating

Material	Form	Manufacturer	Additional layer
Insert	Pyrolytic graphite	Washers with ab radial plane	General Electric	None	
Envelope	Silica phenolic (MX 2641)	Cloth (90° to centerline)	Fiberite	0.25-in.-thick stainless-steel shell	
Run	Chamber pressure, P_c , psia	Oxidant-fuel ratio, O/F	Run time, sec	Total change in effective throat radius, ΔR , in.	Remarks
342	99 to 100	2.10	60.3	-0.0025	Timed shutdown; washers separated
359	104.5 to 100.5	1.77	120.7	.015	Out of propellant
361	105.5 to 99.5	1.86	125.9 306.9	-----	Lost insert

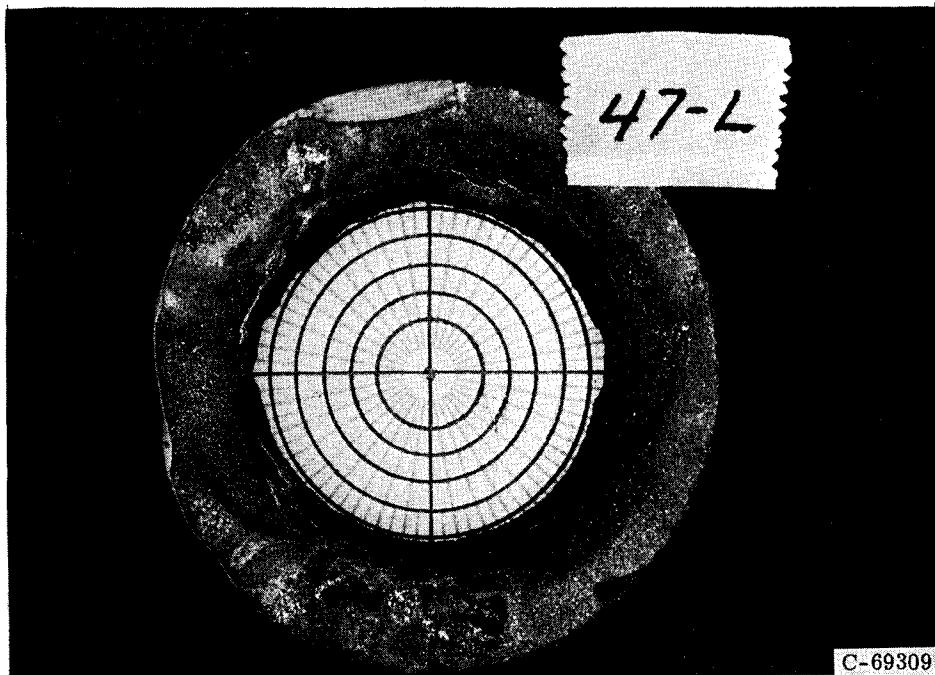
(46) Insert 46; configuration B; injector 12; characteristic length, 50; no precoating; 0.125-inch-thick coating formed during firing

Material	Form		Manufacturer	Additional layer
Insert	JTA graphite (48 C - 35 Zr - 8 B - 9 Si)	Molding		National Carbon	0.125-in.-thick stainless-steel sleeve at insert outside diameter with 0.005 inter- ference fit
Envelope	Silica phenolic (MX 2641)	Cloth (90° to centerline)		Haveg	0.25-in.-thick stainless-steel shell
Run	Chamber pressure, P_c , psia	Oxidant-fuel ratio, O/F	Run time, sec	Total change in effective throat radius, ΔR , in.	Remarks
212	96 to 90.5	1.60	57.0	---	Circumferential cracks; pieces missing

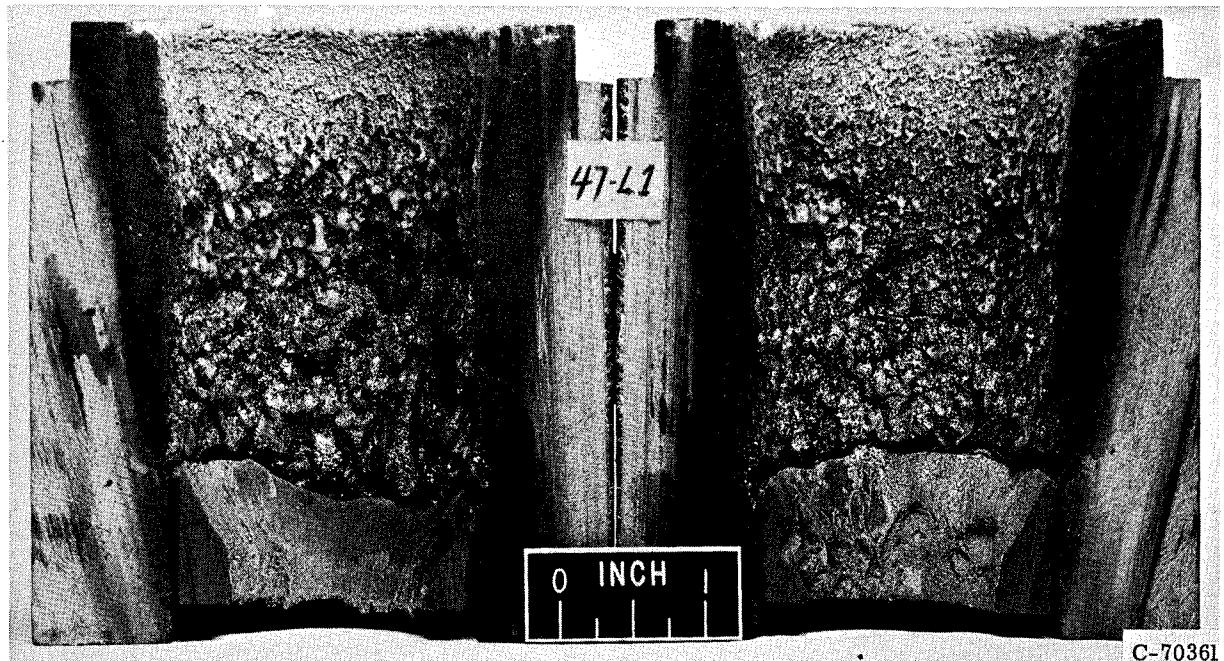
(47) Insert 47; configuration B; injector 11; characteristic length, 67; no precoating; preoxidized coating partially removed during firing

Material	Form		Manufacturer	Additional layer
Insert		JTA graphite (48 C - 35 Zr - 8 B - 9 Si)	Molding		National Carbon	0.04-in.-thick Rokide Z on in- sert outside diameter
Envelope		Silica phenolic	Molded squares		Haveg	0.25-in.-thick stainless-steel shell
Run	Chamber pressure, P_c , psia	Oxidant-fuel ratio, O/F	Run time, sec	Total change in effective throat radius, ΔR , in.	Remarks	
279	104.5 to 98.5	2.04	60.2	0.007	Timed shutdown	
282	100 to 92	1.83	69.3	.042	Low chamber pres- sure shutdown	
			129.5

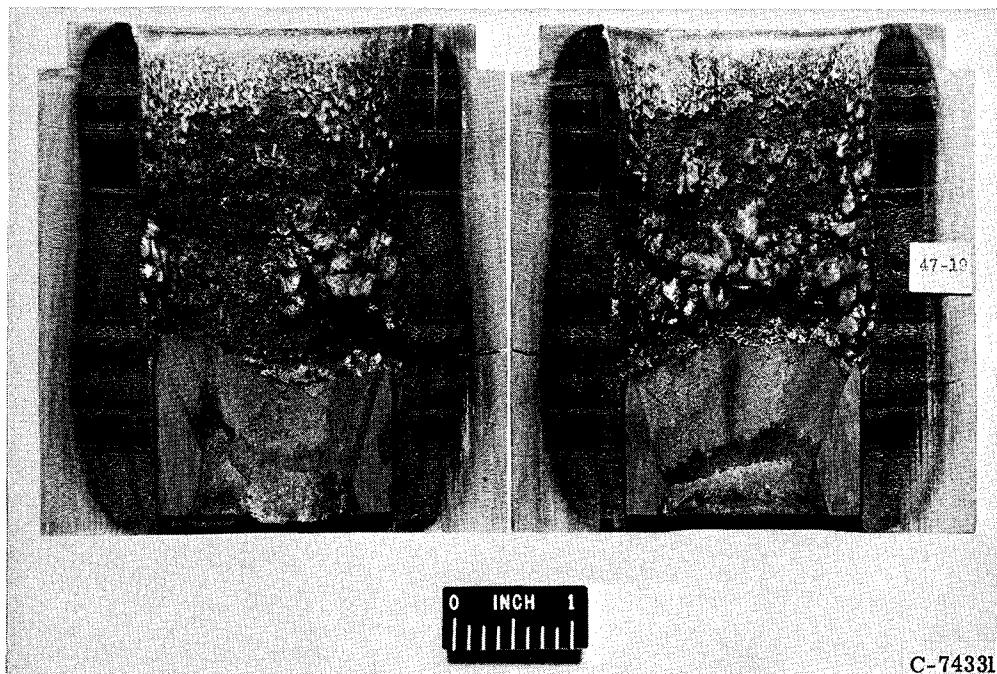
(48) Insert 48; configuration D; injector 11; characteristic length, 66; no coating

Material	Form	Manufacturer	Additional layer	
Insert	JT 0981 (48 C - 35 Zr - 17 Si)	Molding	National Carbon	None	
Envelope	Silica phenolic (MX 2641)	Cloth (90° to centerline)	Haveg	0.25-in.-thick stainless-steel shell	
Run	Chamber pressure, P_c , psia	Oxidant-fuel ratio, O/F	Run time, sec	Total change in effective throat radius, ΔR , in.	Remarks
17	104.5 to 89.1	1.81	61.7	0.0065	Timed shutdown; flaky oxide on surface
42	93.3 to 85.7	1.80	139.7 201.4	.0325	Low chamber pressure shutdown

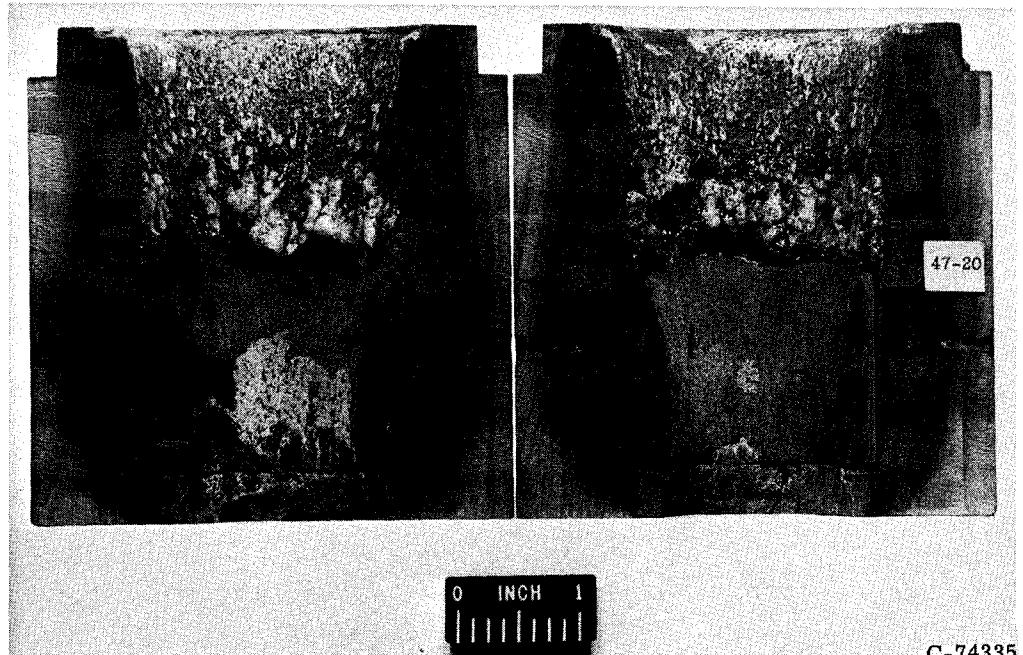
(49) Insert 49; configuration D; injector 11; characteristic length, 66; no coating

Material	Form		Manufacturer	Additional layer
Insert		JO 0981 (48 C - 35 Zr - 17 Si)	Molding		National Carbon	None
Envelope		Silica phenolic (MX 2641)	Cloth (90° to centerline)		Haveg	0.25-in.-thick stainless-steel shell
Run	Chamber pressure, P_c , psia		Oxidant-fuel ratio, O/F	Run time, sec	Total change in effective throat radius, ΔR , in.	Remarks
18	99.1 to 97.3		2.19	62.5	0.011	Timed shutdown; flaky oxide formed
43	98.0 to 82.7		2.03	102.5 165.0	.070	Low chamber pressure shutdown

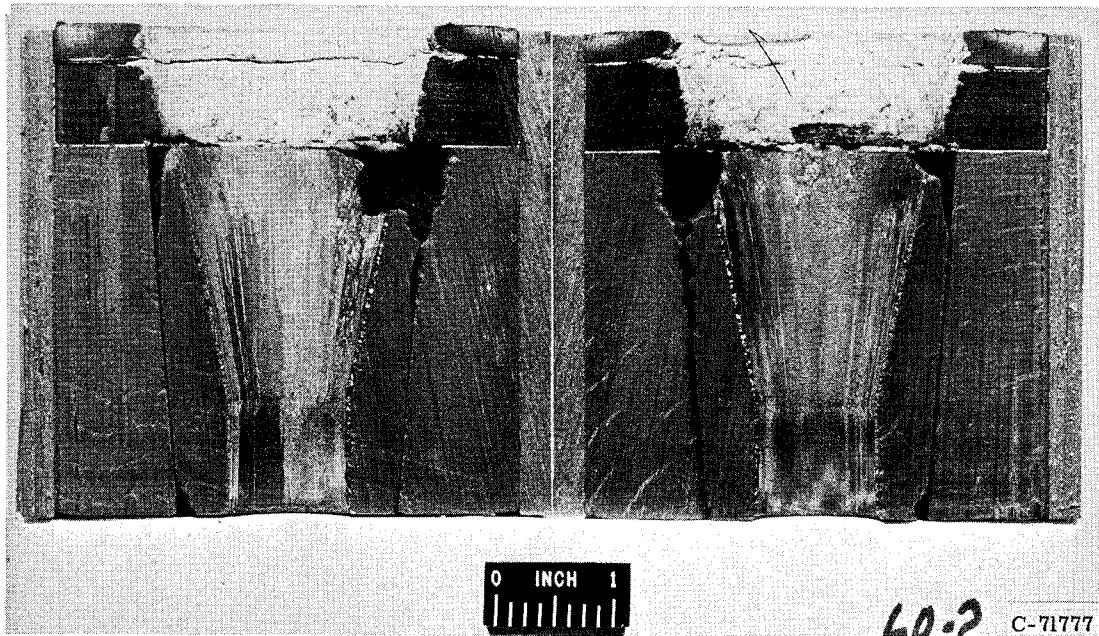
(50) Insert 50; configuration F

Material		Form		Manufacturer	Additional layer
Coating		0.040-in. -thick SiC		Pyrolytic			
Insert		Graphite		Molded		Marquardt	None
Envelope		Graphite (MX 2641) upstream		Molding, cloth (90° to centerline)		Marquardt Fiberite	0.3125-in. -thick stainless-steel shell
Run	Injector	Charac- istic length, L^* , in.	Chamber pressure, P_c , psia	Oxident- fuel ratio, O/F	Run time, sec	Total change in effective throat radius, ΔR , in.	Remarks
221	12	68	100.5 to 98.5	1.46	61.9	0	Timed shutdown
222	12	68	101.5 to 99.5	1.45	121.9		Timed shutdown
235	11	94	96.3 to 93.5	1.54	183.7		Out of propellant
237	11	94	103.5 to 92.5	1.80	252.3		Out of propellant
243	11	94	97.0 to 94.5	2.62	37.0		Manual abort; wrong O/F
244	11	94	96.5 to 94.5	2.06	128.2		Out of propellant
247	10	94	97.5 to 97.0	1.82	129.3		Out of propellant
322	11	94	101.5 to 101.5	1.75	207.3		Out of propellant
323	11	94	103.9 to 103.4	1.56	107.5		Out of propellant

324	11	94	102.5 to 102.5	1.60	177.3		Out of propellant; leading edge failure
					1406.6

Insert	Lewis designation	Description	Total time, sec	Number of runs	Overall erosion rate, mils/sec	Primary failure mechanism	Located in table -
(g) Coated materials							
50	60-2	0.040-in.-thick RM 005 SiC on graphite in graphite	1407	10	0	Leading-edge failure; graphite gave large heat sink and high outside diameter temperature	I(50)
51	60-3	0.040-in.-thick RM 005 SiC on graphite in ablative material	751	4	0	Leading-edge failure and ablative char-through	I(51)
52	47 H	0.020-in.-thick pyrolytic graphite on graphite cloth	86	2	Not measured	Coating largely consumed and leading-edge failure	I(52)
53	47 Q	0.060-in.-thick pyrolytic graphite on graphite cloth	190	2	.67	Coating largely consumed and leading-edge failure	I(53)
54	47 P	0.020-in.-thick boron alloy on ATJ graphite	112	3	1.32	Coating completely consumed	I(54)
55	47 V	0.010-in.-thick TaC on ATJ graphite	56	1	1.29	Coating completely consumed	I(55)

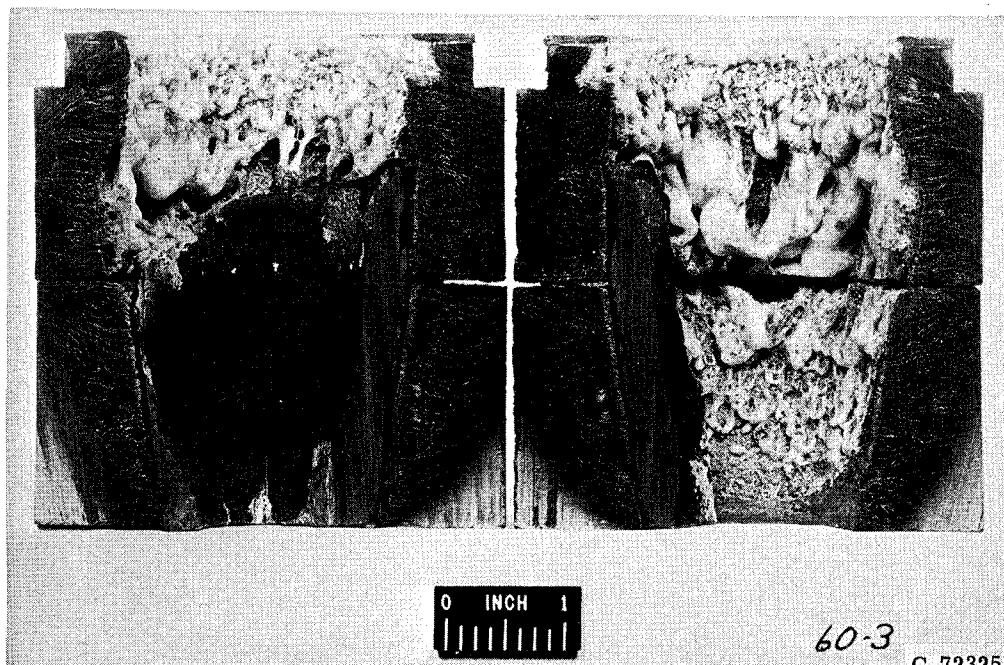
(51) Insert 51; configuration F; injector 11; characteristic length, 94

Coated materials. - Six coatings and three substrates were evaluated. The materials and test results are listed in table V(g). The most successful coating was pyrolytic silicon carbide on a graphite substrate with an increased insert inlet diameter (fig. 6(f)) to alleviate erosion of the ablative material at the insert-ablative material interface. The silicon-carbide coated insert (insert 50) was tested in a configuration providing a large graphite heat sink (see table I(50)). In this configuration the coating was practically indestructible; however, some local spalling was observed, and the outside diameter of the envelope reached a temperature of approximately 1000° F during steady-state firing. This configuration was not applicable directly to an actual ablative engine. When a thinner graphite substrate was used in an ablative envelope (insert 51), the silicon carbide coating experienced no failure until 230 seconds of the fourth firing at 722 seconds of total run time. The failure at that time was associated with complete charring of the ablative envelope (see table I(51)) causing an increase in coating temperature. The pyrolytic-silicon-carbide-coated insert (insert 51) was the best of all the inserts tested.

The final design consideration should be the thickness relation between the insert and the ablative envelope required by the firing time and duty cycle of a particular engine. Failure of inserts 45 and 51, for instance, was associated with complete char-through of the ablative envelope. Each insert design requires knowledge of the precise firing requirements if a realistic approach is to be made. Some insert materials may be applicable only to single long-duration, firings while others may be more applicable to cyclic operation.
